Use of safety harness tethers on sailing yachts

Fatal accident on board the sailing yacht

CV30

MAIB SAFETY BULLETIN 1/2018

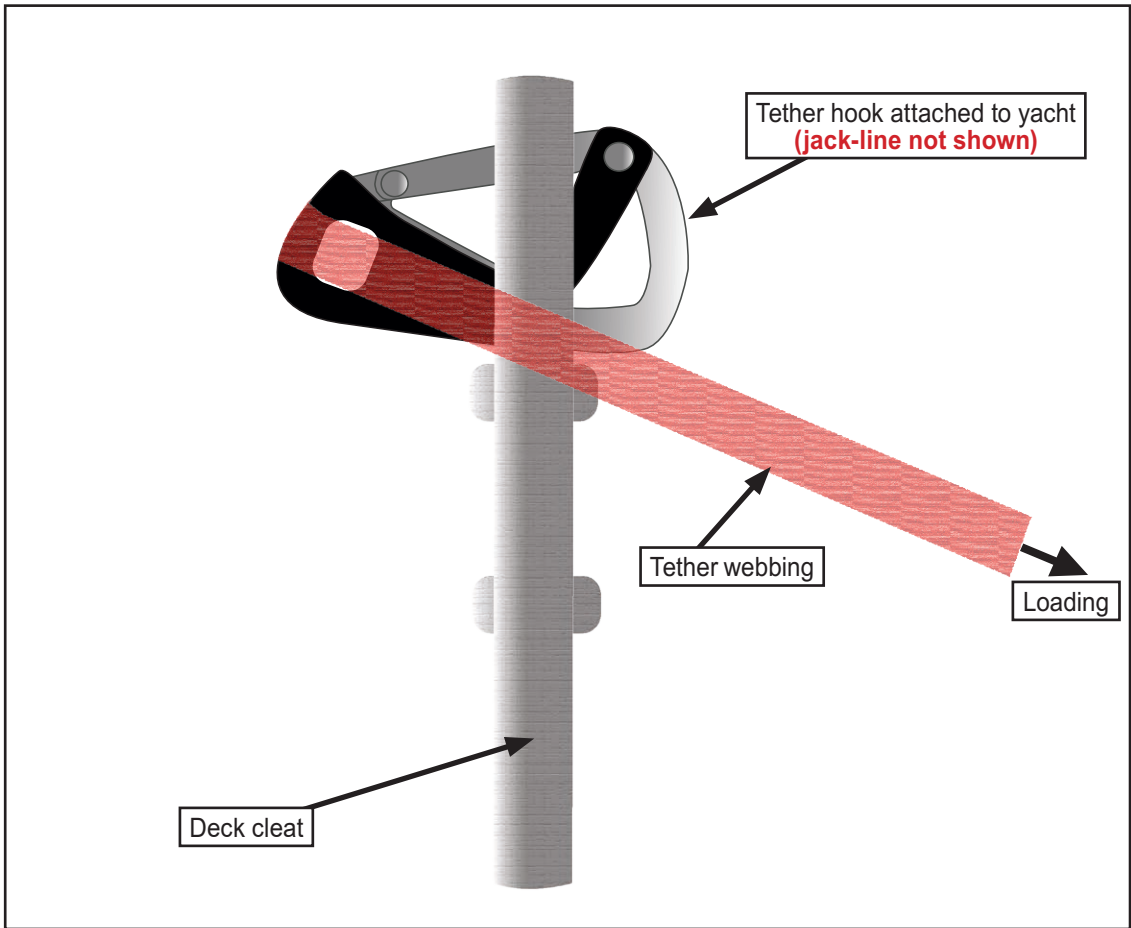
A safety issue identified during the investigation was that the hook on the end of Mr Speirs' tether had become caught under a deck cleat (see **Figure 1**), resulting in a lateral loading that was sufficient to cause the hook to distort (see **Figure 2**) and eventually release.

Figure 1: Tether hook under deck cleat

To prevent the strength of a safety harness tether becoming compromised in-service due to lateral loading on the tether hook, the method used to anchor the end of the tether to the vessel should be arranged to ensure that the tether hook cannot become entangled with deck fittings or other equipment.
